# Assessment of Dam Safety

## Coal Combustion Surface Impoundments (Task 3)

### Final Report

Progress Energy  
Carolinas  
Cape Fear Plant

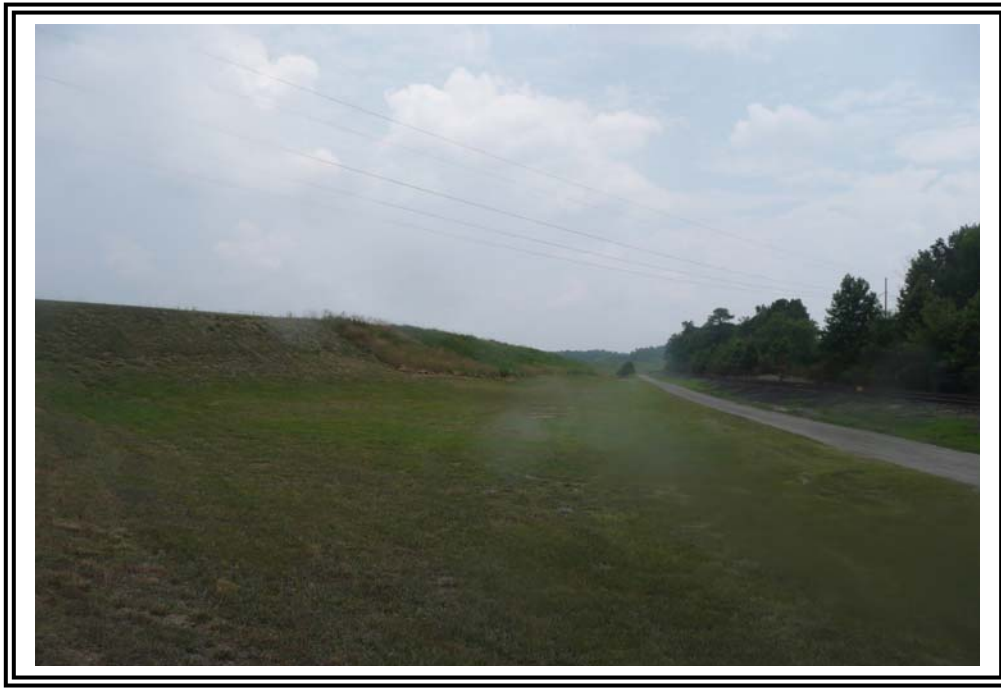
1

Northwest end of 1985 Ash Pond West Dike, looking southeast.

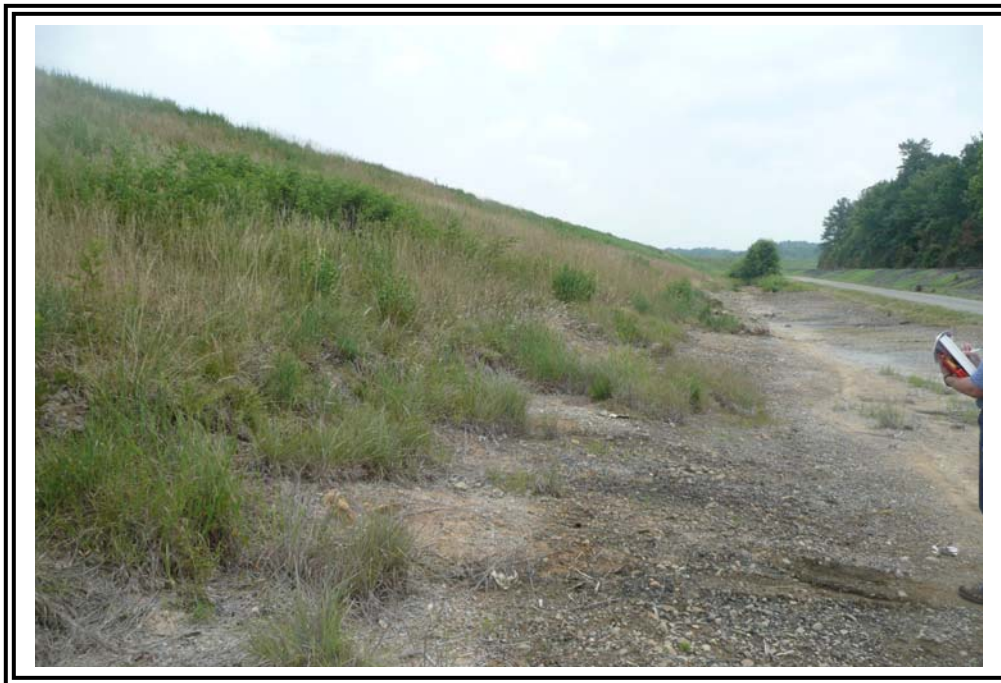
2

Along the toe of the northern portion of the west dike there is an area, which Progress Energy Carolinas personnel indicated storm water ponds between the toe of the dike and the access road that runs between the dike and the railroad tracks. The area is devoid of vegetation and was dry during our site visit as shown in Photo 2. The ponding water in this area has resulted in some “beaching” erosion at the toe of the northern portion of the west dike as shown in Photo 3.

1985 Ash Pond West Dike toe along the northern portion of Dike.

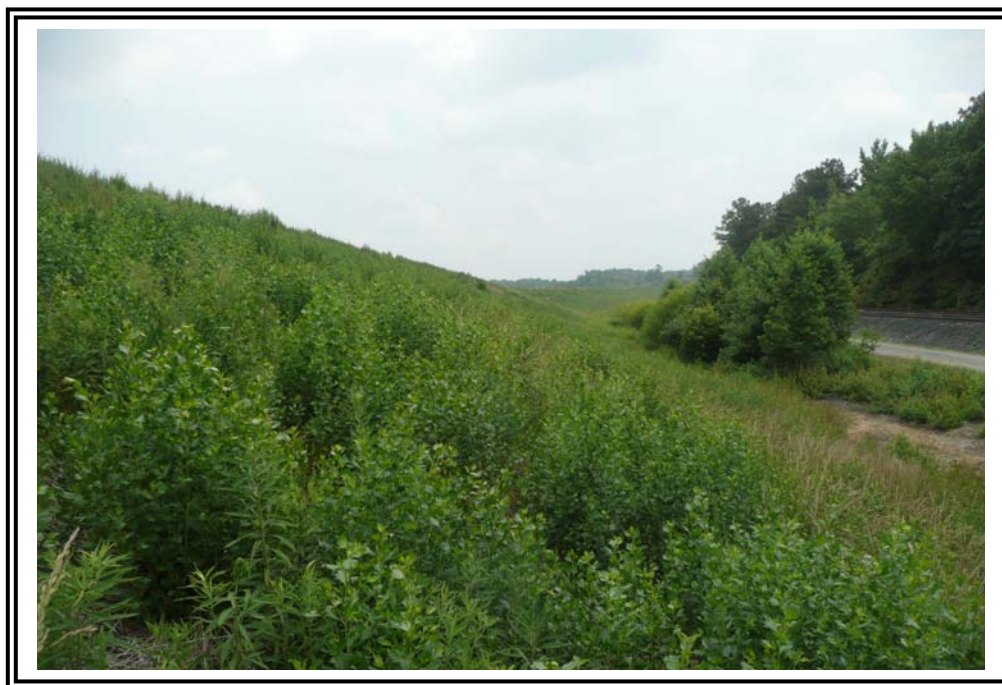
4

1985 Ash Pond West Dike approaching bend, looking southeast.

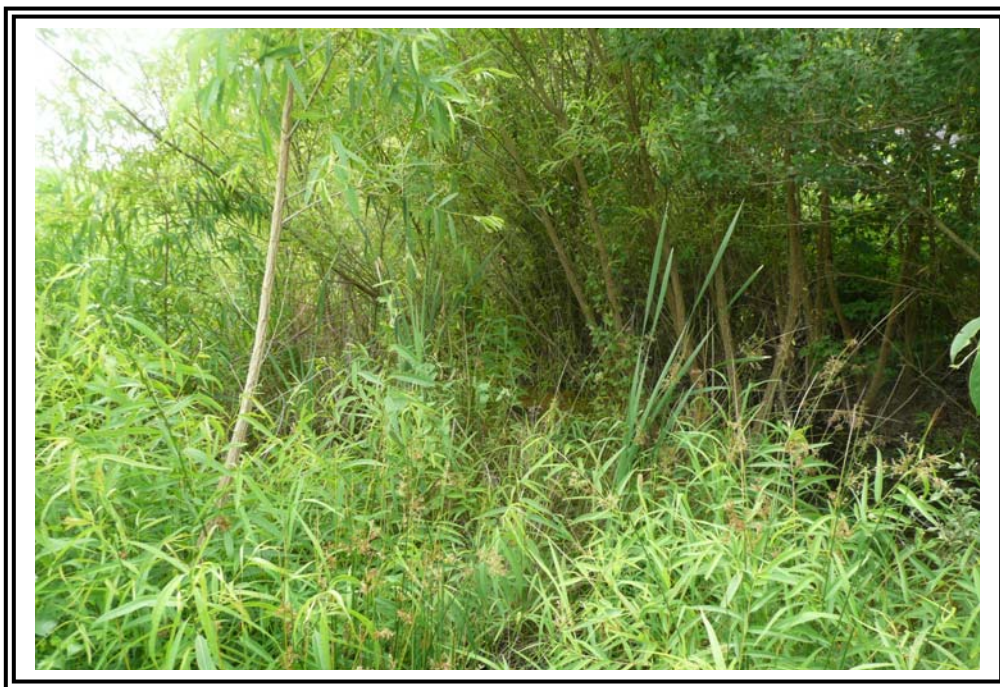
5

Woody growth along the West Dike of the 1985 Ash Pond.

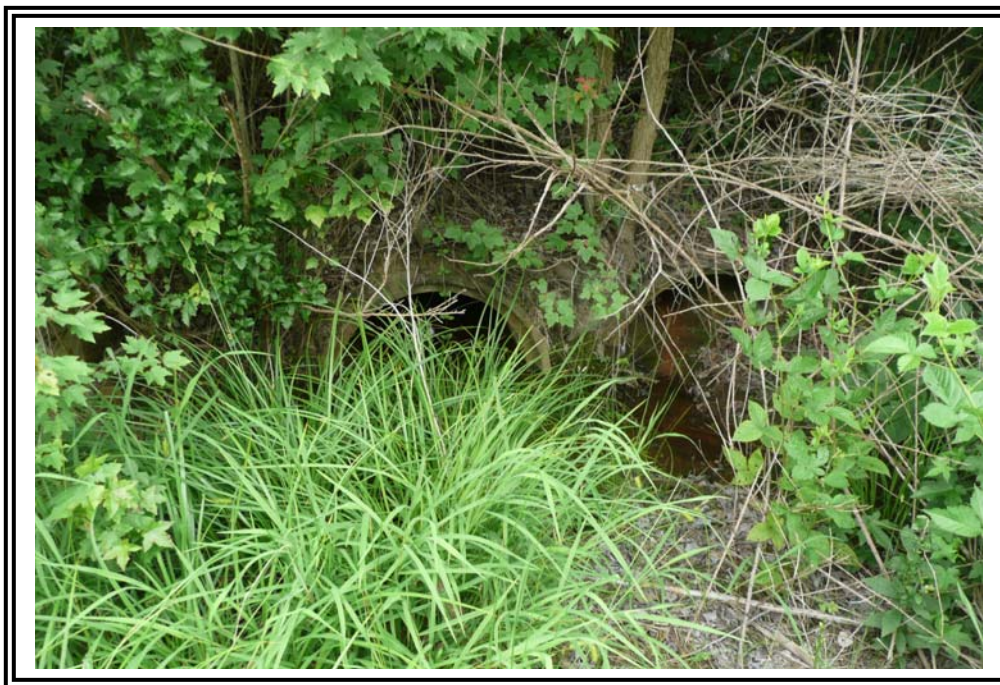
6

Double culvert under railroad spur for ditch line along West Dike of 1985 Ash Pond.

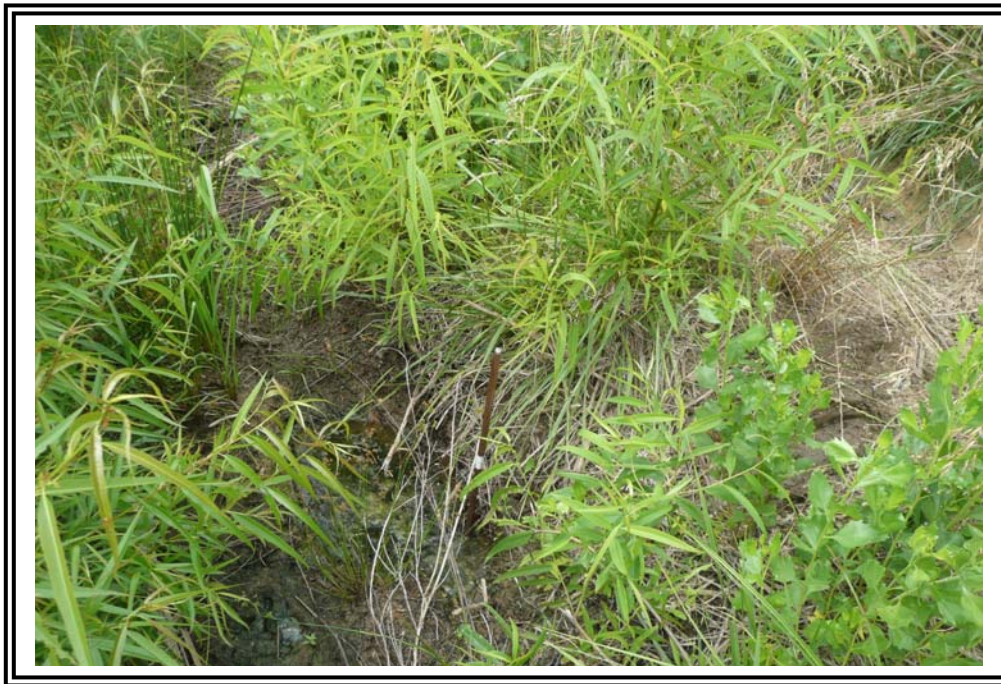
Soft soil at the toe of the 1985 Ash Pond West Dike. Probe pushed into the ground about 2 feet.

Along the west dike of the 1985 Ash Pond, an area of ponded water occurs between the toe of the dike and the access road. While there is a twin culvert extending below the access road and railroad tracks, it appears from evidence of the depth of ponding and erosion from this ponding observed during CHA's visit, that the capacity and or pitch of these culverts is inadequate to drain the area. The result of the standing water is not only the softening exhibited in Photos 8 and 9 but beaching erosion resulting in toe loss as shown in Photo 3.

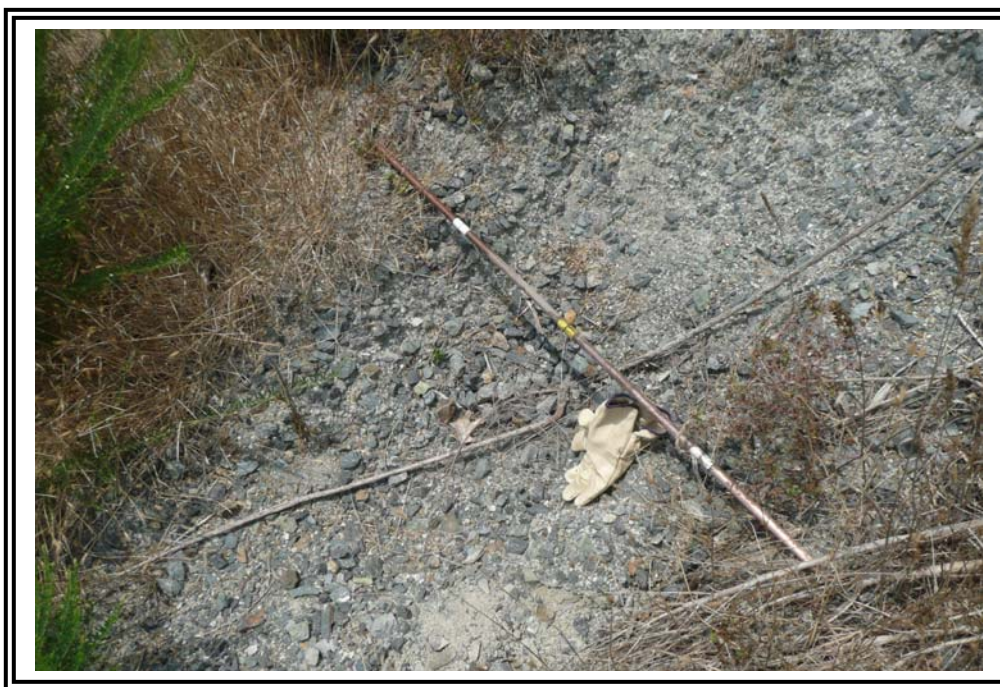
10

Stone filled erosion and /or abandoned rodent hole on the 1985 Ash Pond West Dike.  
Progress Energy reports filling rodent holes and erosion features with gravel.

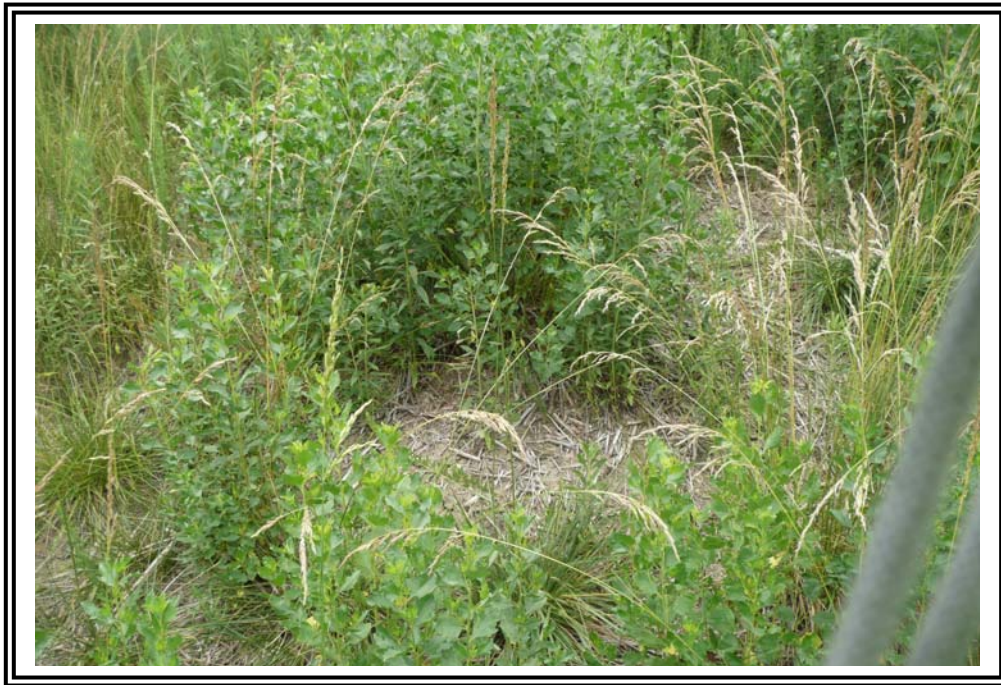
11

Sparse and weedy vegetation cover on the 1985 Ash Pond West Dike.

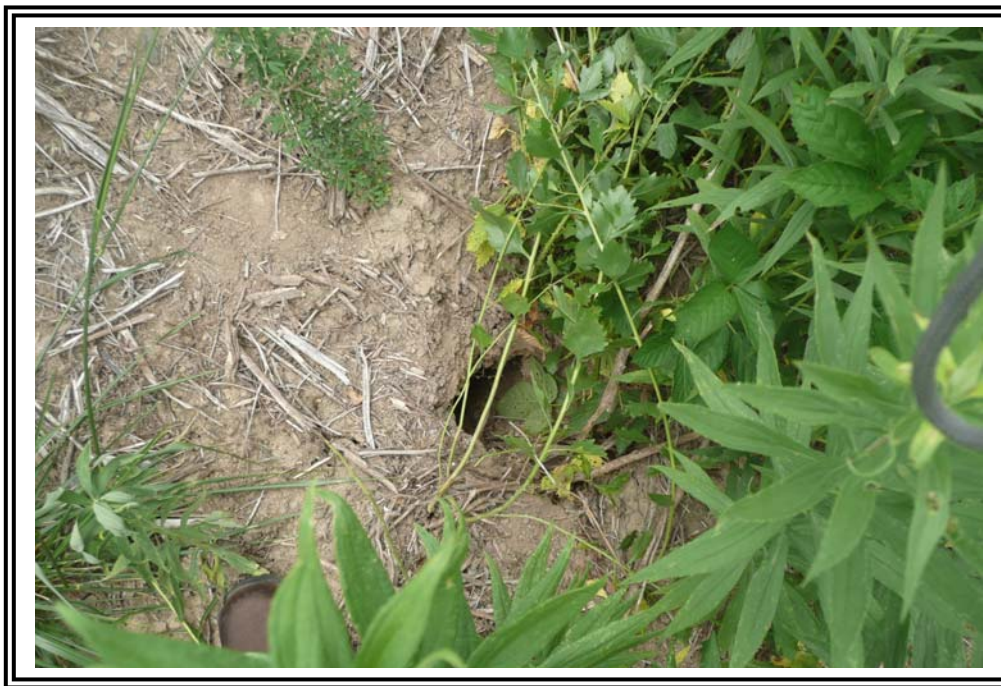
12

Rodent hole on the 1985 Ash Pond West Dike.

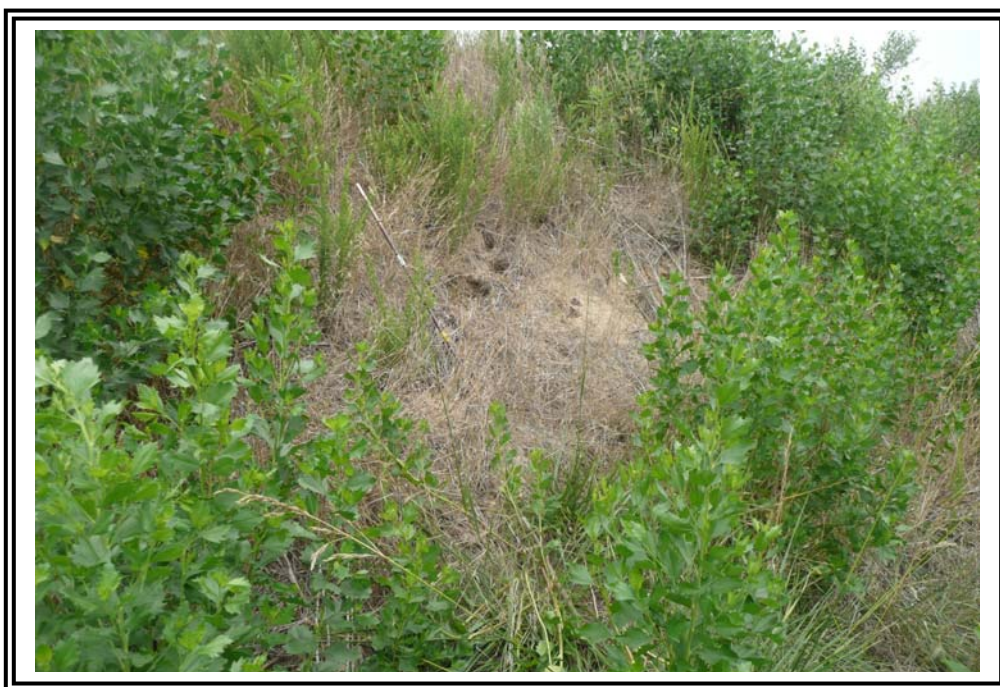
13

Scarp about 3 to 4 feet high near the top of the 1985 Ash Pond West Dike.

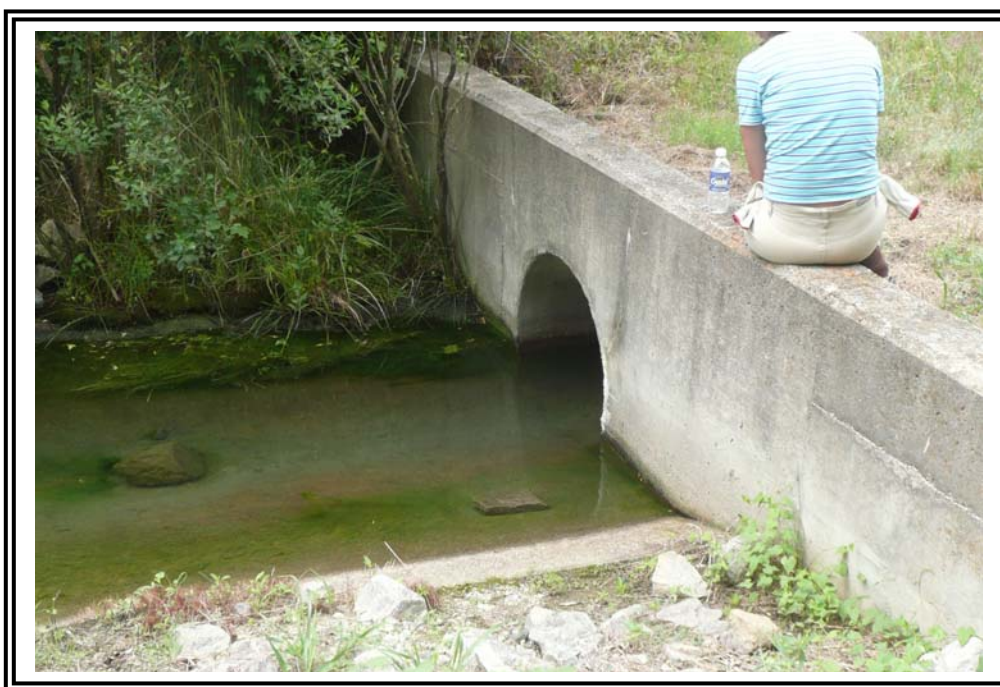
14

Culvert under the access road at the toe of the 1985 Ash Pond West Dike outlet channel.

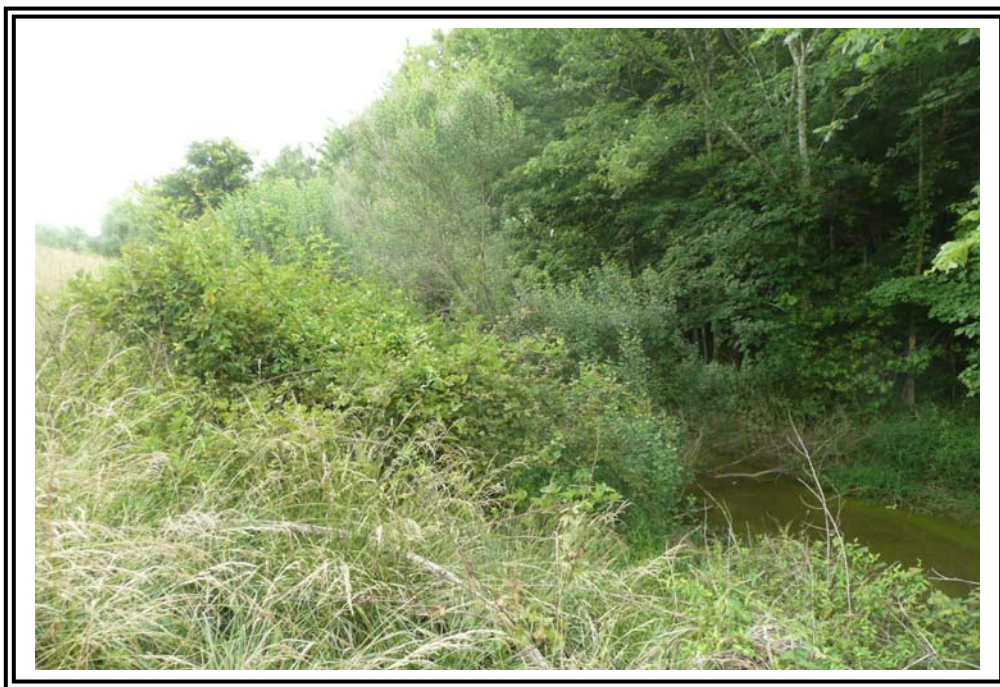
15

Drainage swale/channel adjacent to toe of 1985 Ash Pond.

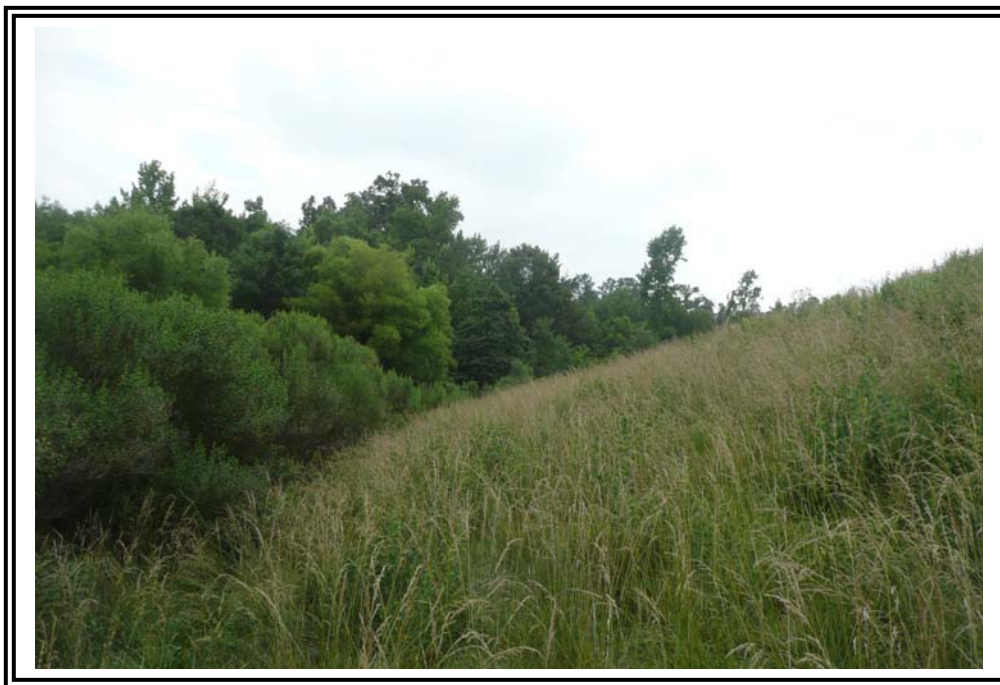
16

Southeast corner of the 1985 Ash Pond Dike, looking southwest.

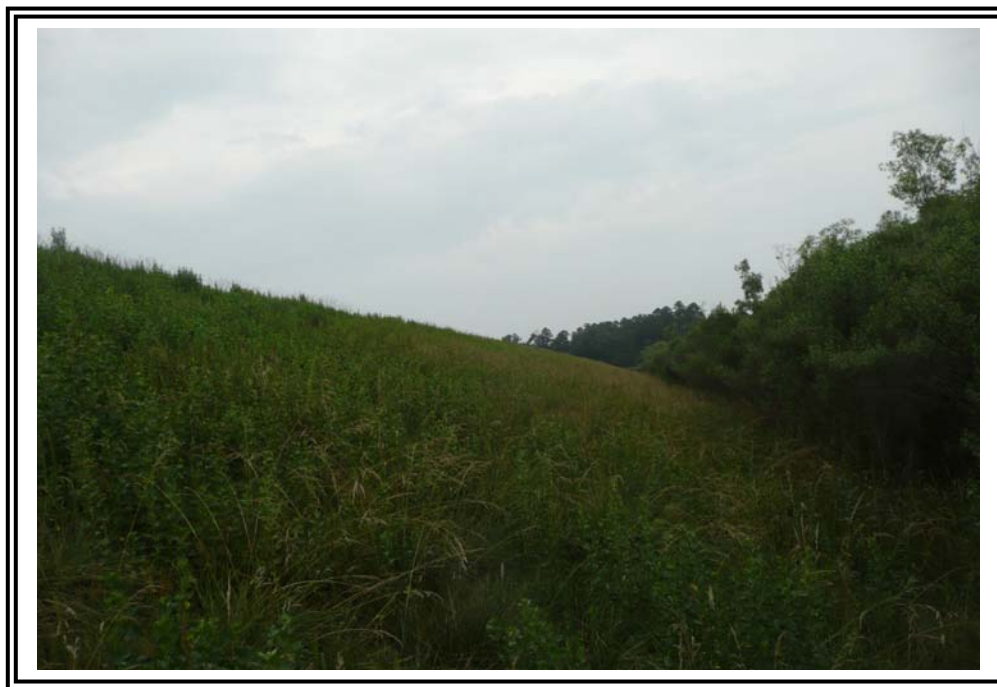
17

South Dike of the 1985 Ash Pond, looking northeast.

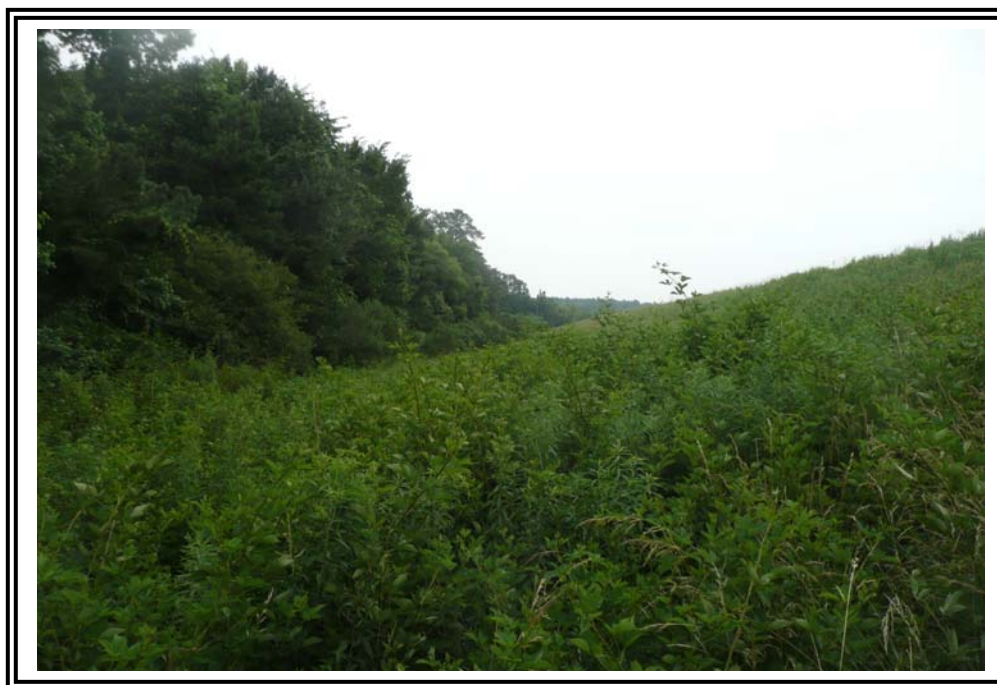
18

East Dike of the 1985 Ash Pond, looking south.

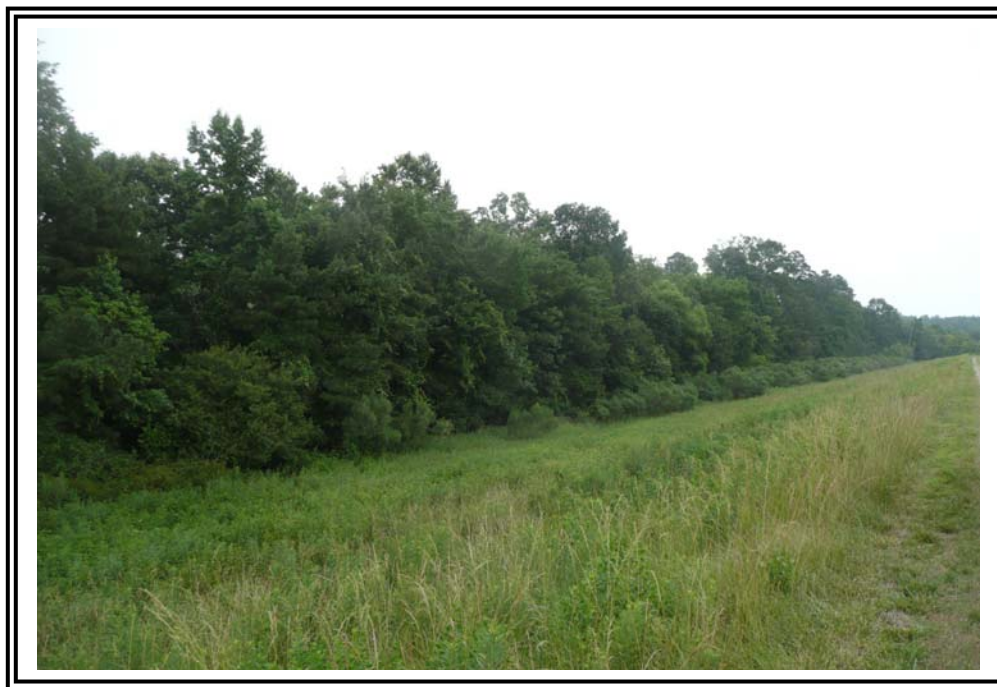
19

East Dike of the 1985 Ash Pond, looking southeast.

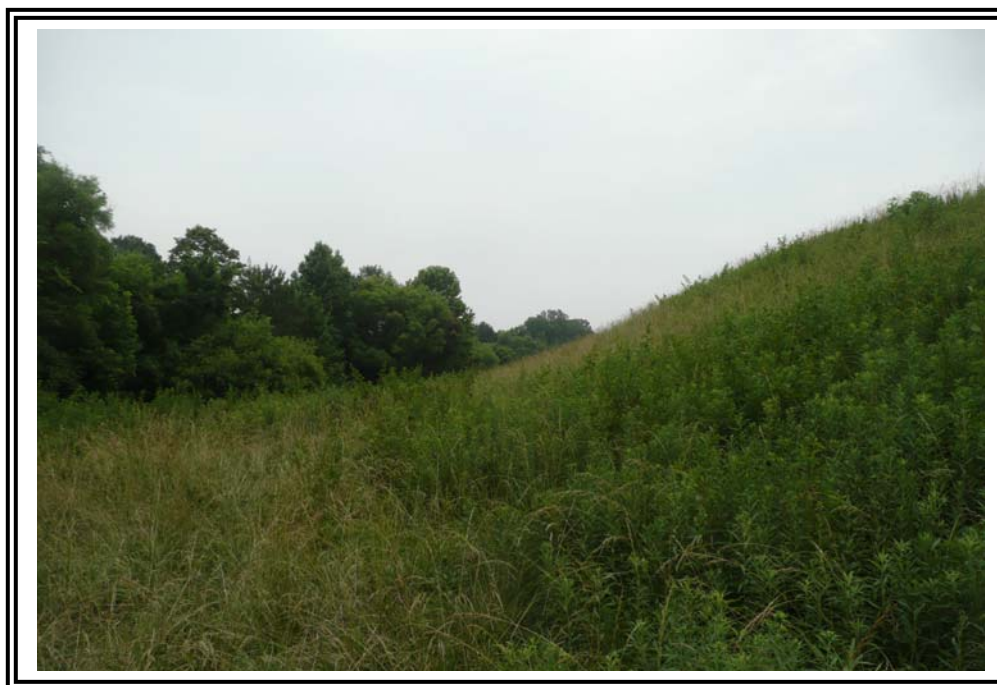
20

Corner at the north and northeast Dike of the 1985 Ash Pond, looking east.

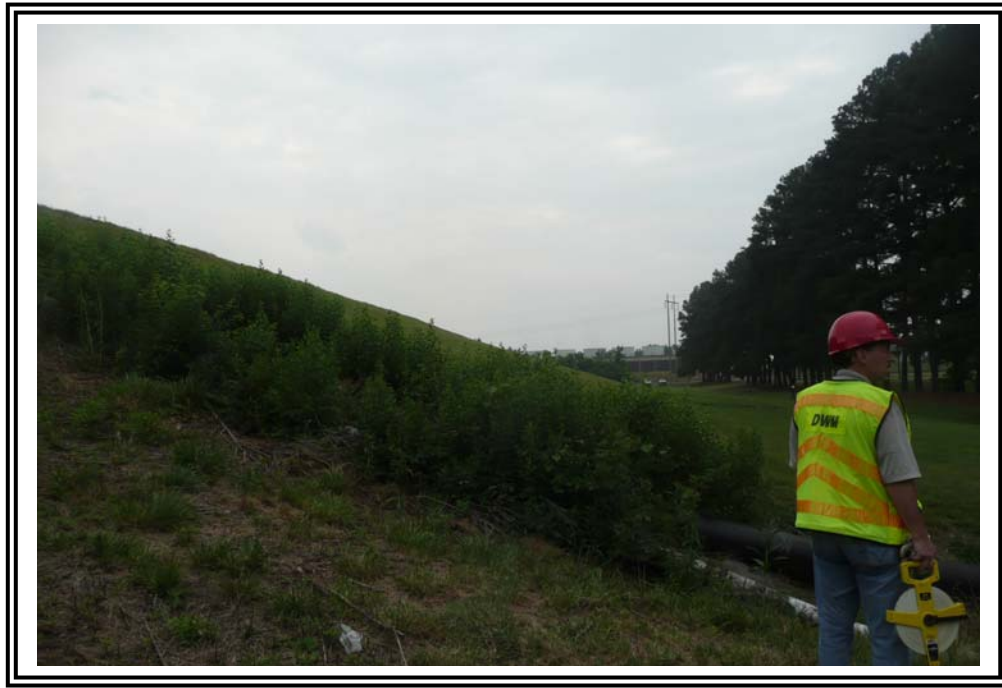
21

North Dike of the 1985 Ash Pond, looking southwest.

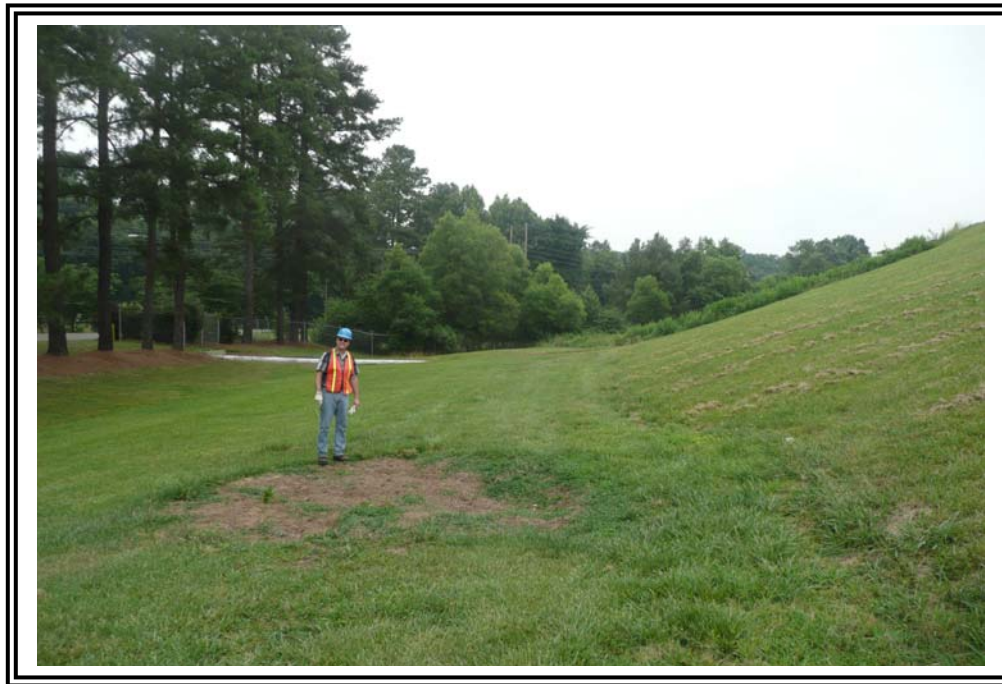
22

Toe of the North Dike of the 1985 Ash Pond, looking northeast.  
Note: Bare patch at the toe of the Dike.

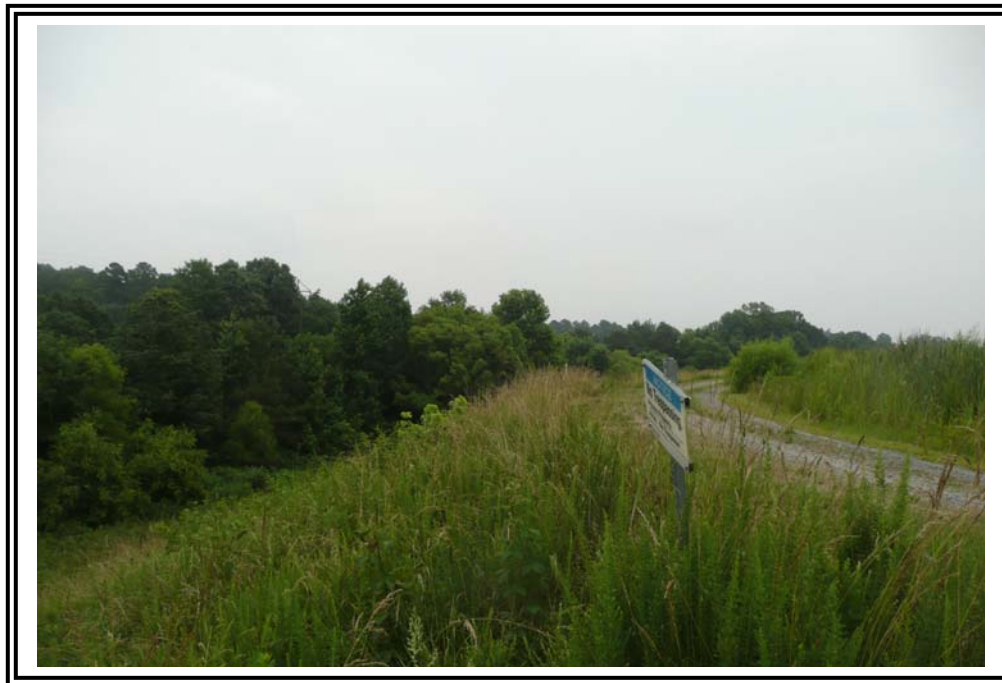
24

Dike crest at the north corner of the 1985 Ash Pond, near the ash line crossing.

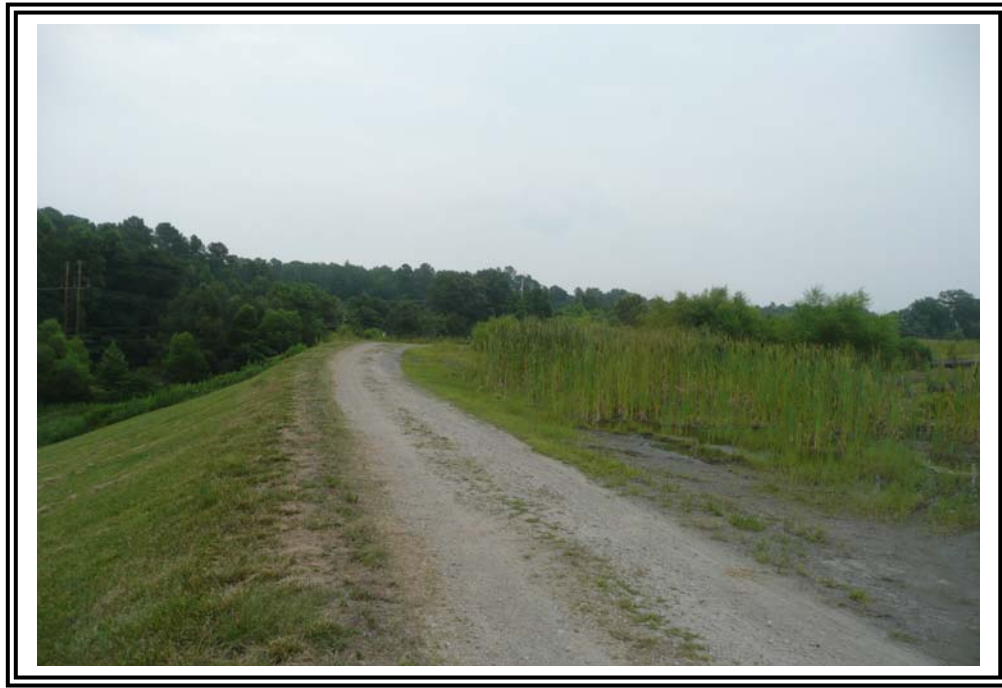
25

North Dike crest of the 1985 Ash Pond, looking northeast.  
Note: Ash level is approximately at the crest of the Dike.

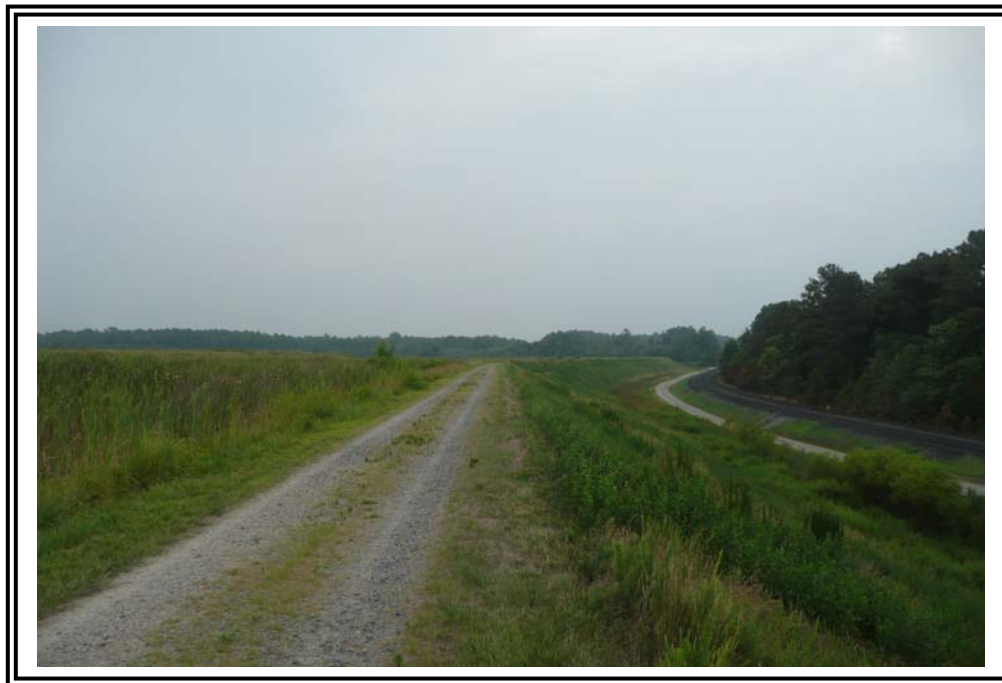
26

West Dike crest of the 1985 Ash Pond, looking southeast. Note: "Pond within a pond" to the upstream side of the crest. Ash in 1985 Ash Pond approximately at the crest of the dike.

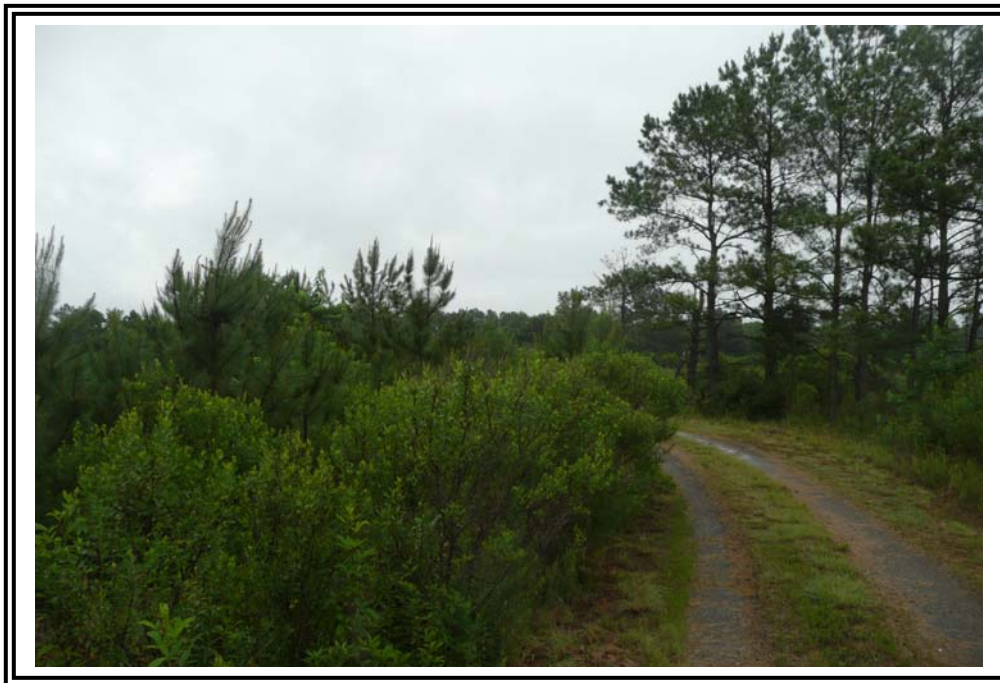
42

The crest alignment of the 1978 dikes do not appear changed from historic site plans. The 1978 Ash Pond contains water at the southern end of the pond and sluiced, but dried ash in the northern portion of the pond. In the northern portion of the pond, trees and other vegetation has established on the exposed ash as shown in Photo 66. Photos 41, 42, 45, and 50 show the typical vegetation conditions on the dikes.

North end of 1978 Ash Pond Dike crest. Brush and small Pine trees are in the left of the photo and are on the downstream slope. Tall Pine trees on the right of the photo are in deposited ash within the pond.

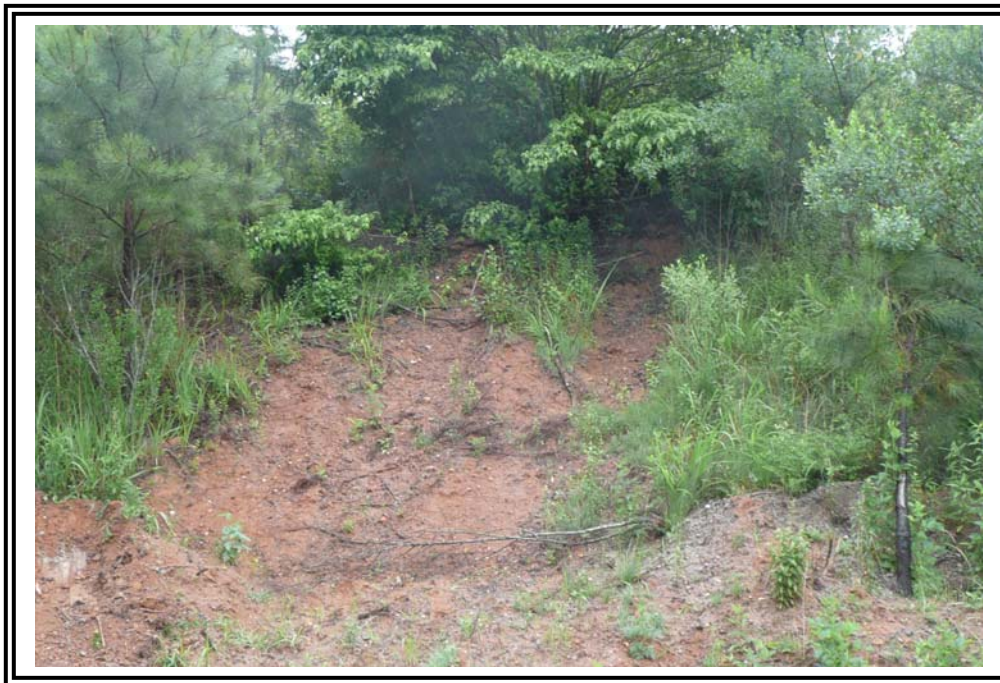
44

Example of poor vegetative cover, erosion, and probable human activity on the downstream slope of the 1978 Ash Pond Dike.

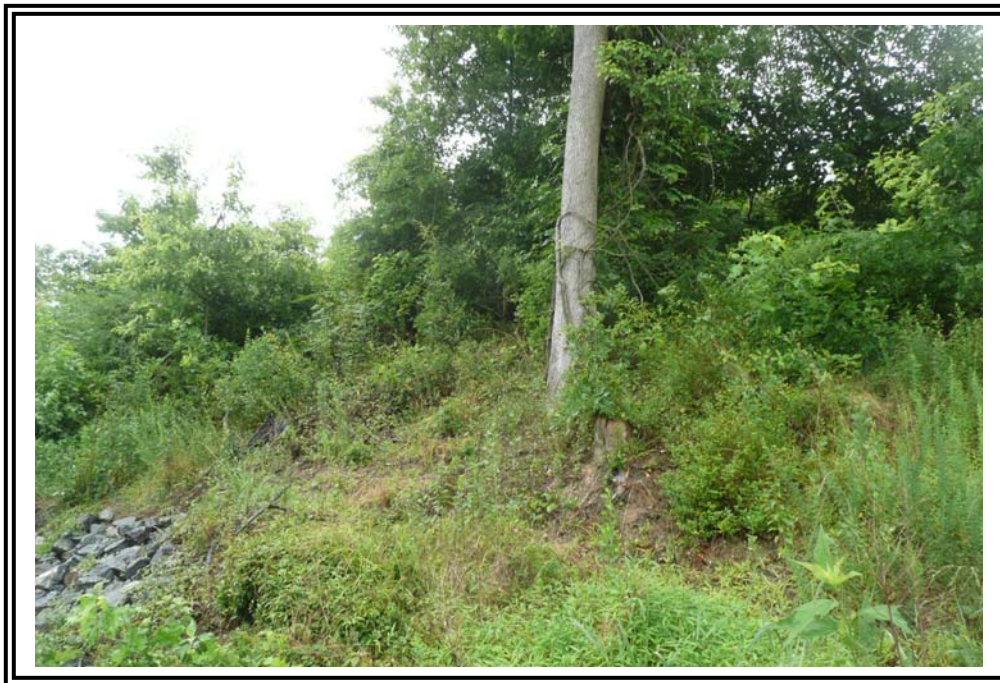
48

Erosion/surface sloughing around the tree stump on the 1978 Ash Pond Dike.

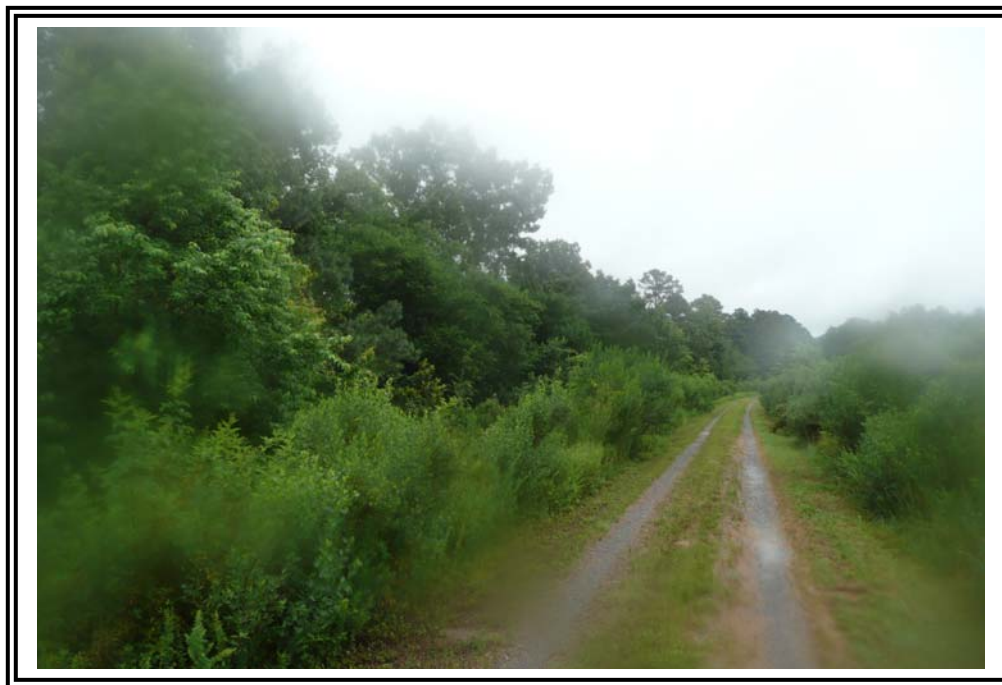
50

Crest of the 1978 Ash Pond Dike approaching the east corner of the Dike, looking south. Note: Taller trees are on the downstream slope in the left of the photo and shorter brush is on the upstream slope in right of the photo.

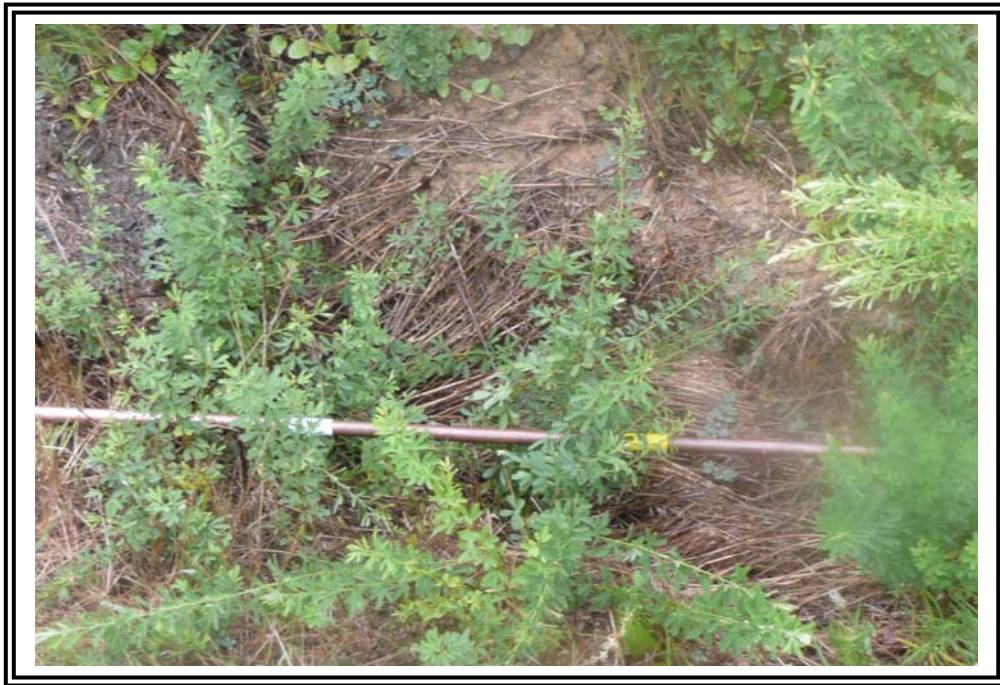
51

Irregular ground surface on the downstream slope at the east side of the 1978 Ash Pond Dike.

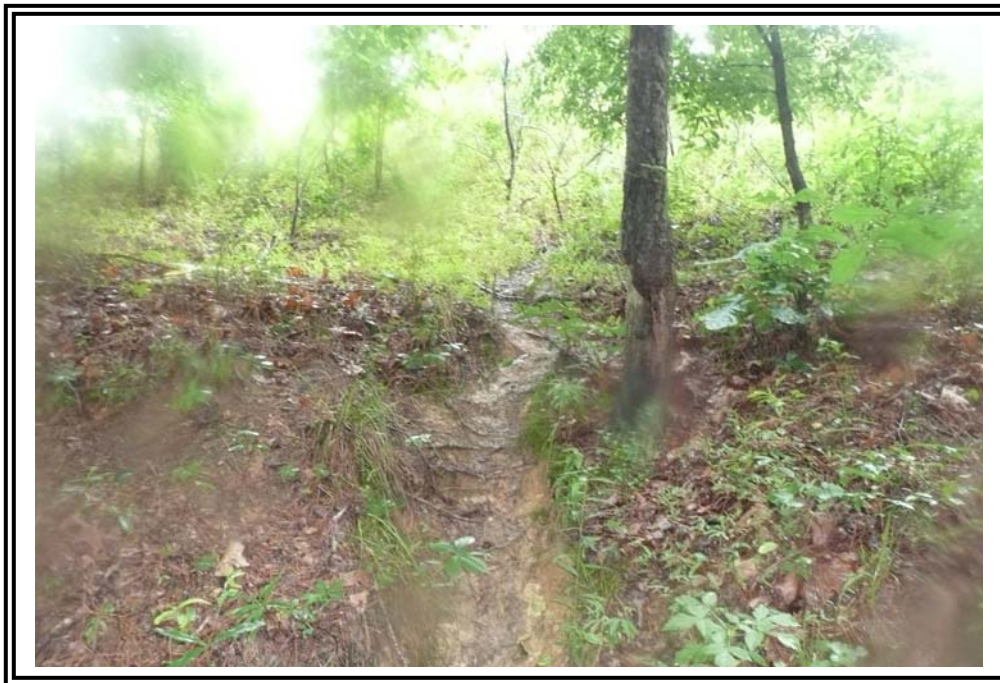
Evidence of soil disturbance from animal activity was observed in a few locations. Photo 52 shows a slide likely resulting from beaver or muskrat activity, and Photo 63 shows an animal burrow.

Animal slide (likely beaver or muskrat) on the downstream slope of the 1978 Ash Pond Dike.

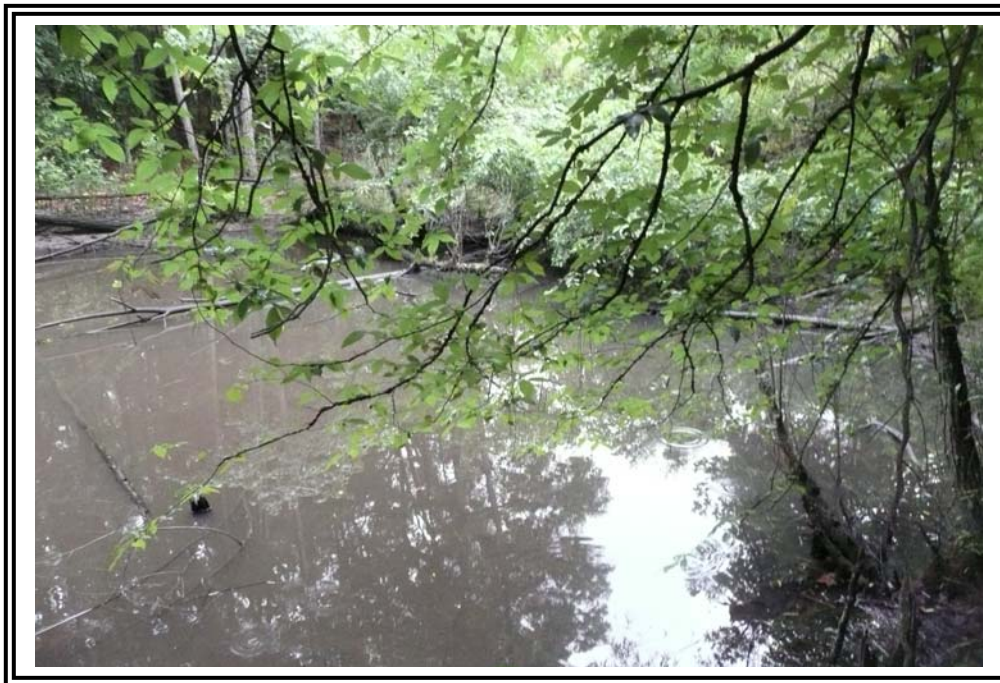
To the west of the outlet pipe discharge is an area of ponded water. The nature of the silty/clayey soils comprising the dikes is to be susceptible to softening when subjected to excess moisture. Photo 58 shows this area.

Ponded area south of the discharge pipe at the toe of the 1978 Ash Pond Dike.  
Reportedly excavated area from former adjacent property owner, who was a brick manufacturer.

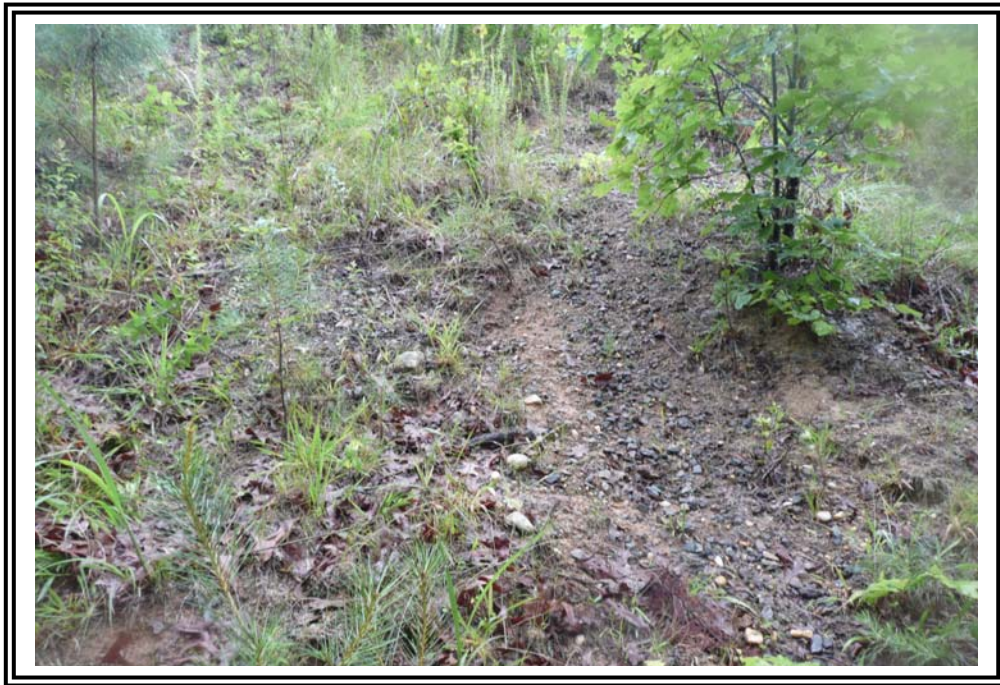
59

Surface erosion southeast of the downstream slope of the 1978 Ash Pond Dike.

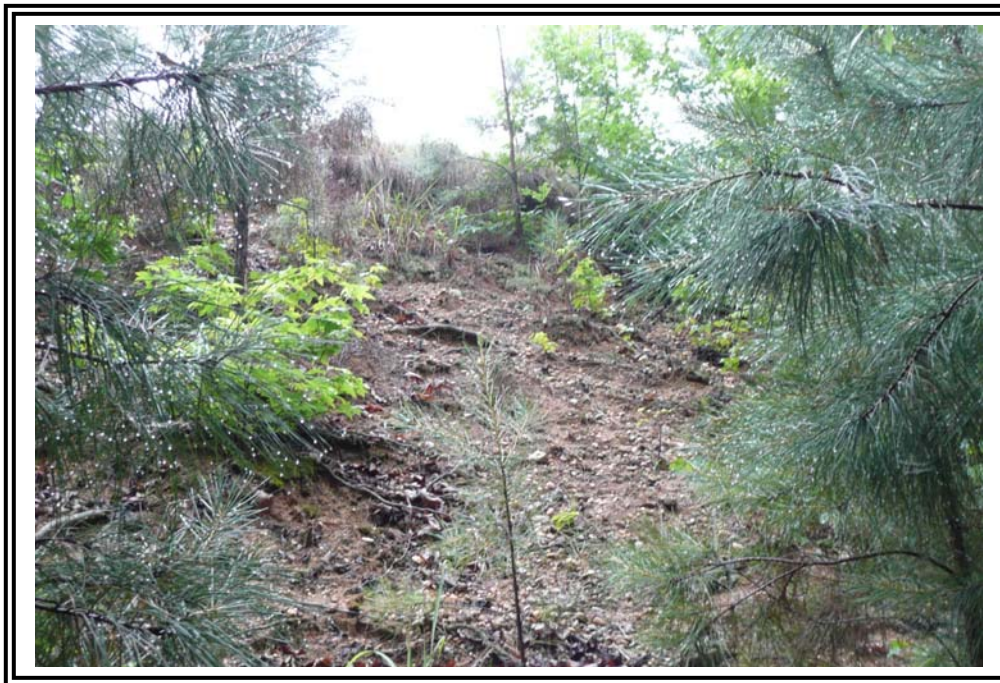
60

Surface erosion southeast of the downstream slope of the 1978 Ash Pond Dike.
